Background-
Water ingress past the front cover is a common cause of failure in the 1838 and 2550 Rock drills.

PART NUMBER	DESCRIPTION
MT3115 3528 008	VENTED SEAL RETAINER

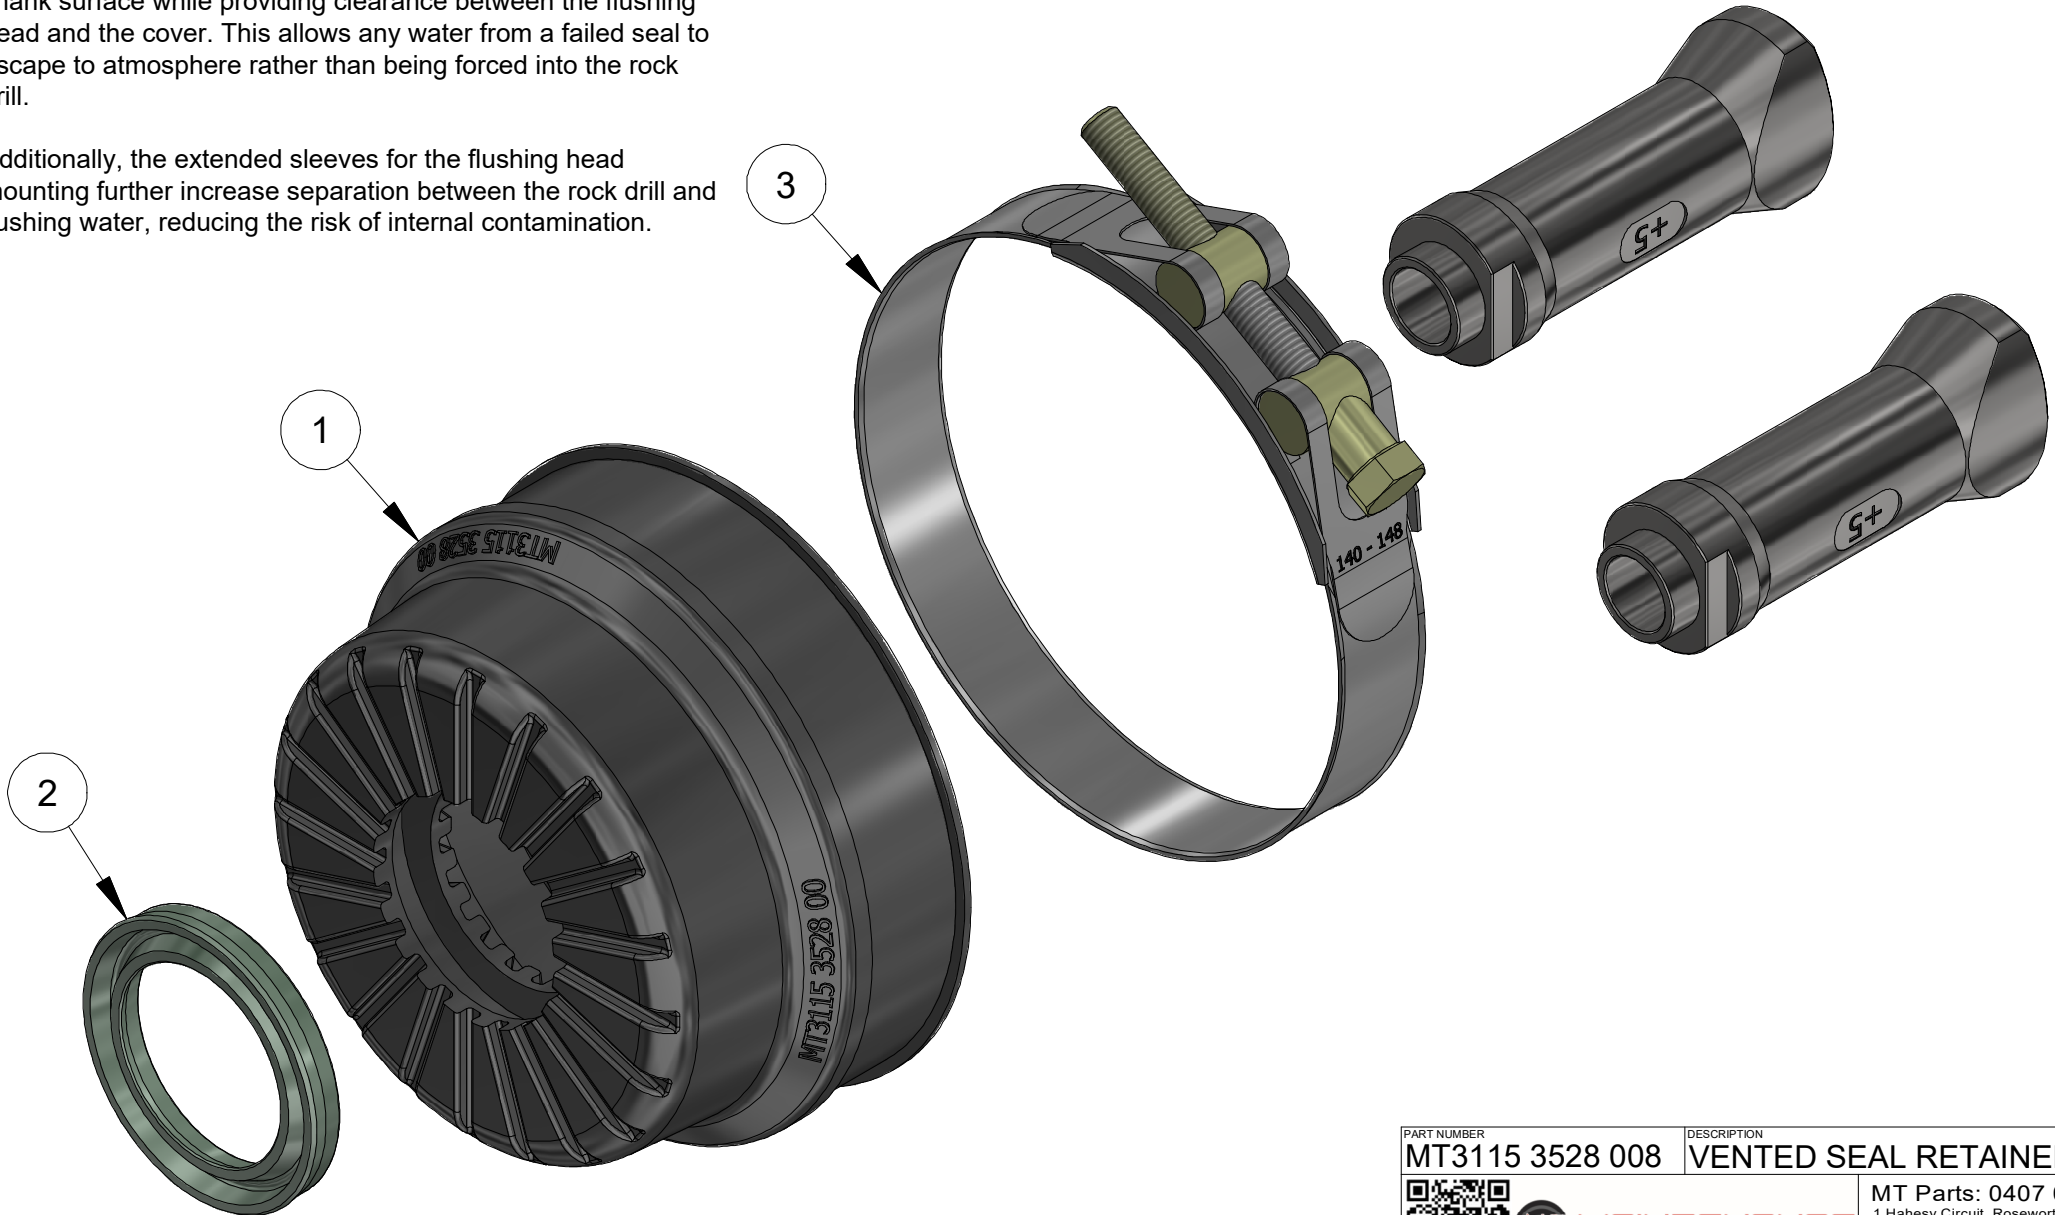
The new cover design ensures consistent seal contact with the shank surface while providing clearance between the flushing head and the cover. This allows any water from a failed seal to escape to atmosphere rather than being forced into the rock drill.

Additionally, the extended sleeves for the flushing head mounting further increase separation between the rock drill and flushing water, reducing the risk of internal contamination.
